FABRICATION AND VERIFICATION TESTING OF ETM 30 CM DIAMETER ION THRUSTERS

FINAL REPORT

APRIL 1977

ION PHYSICS DEPARTMENT STAFF
HUGHES RESEARCH LABORATORIES
A DIVISION OF HUGHES AIRCRAFT COMPANY
3011 MALIBU CANYON ROAD
MALIBU, CALIFORNIA 90265

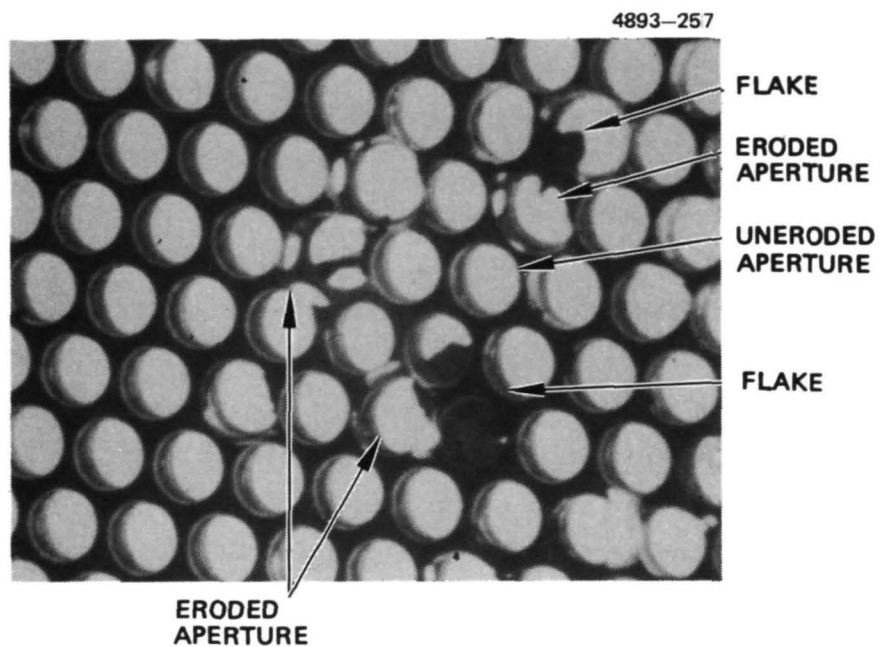
The first evidence of thruster discharge chamber erosion was the observation at test hour 4530 of flakes lying on the upstream side of the screen grid (the thruster was mounted in the vertical vacuum chamber pointing down at a frozen mercury collector). The number and size of flakes varied as the test continued; Figure 31 illustrates this by showing the flakes at test hours 8600 and 10,000. Some of the erosion of the accelerator electrode apertures caused by the flakes is shown in Figure 32. In that figure, the uneroded apertures adjacent to eroded apertures demonstrate the localized nature of the erosion. The source of flakes on the screen electrode is presumed to be spalling of the material which had been sputter eroded from within the discharge chamber and deposited on other discharge chamber surfaces. This theory was substantiated at test hour 5845 when a small hole was observed in the center of the cathode baffle. The cold-rolled steel baffle had originally been 0.075 cm thick. The maximum dimension of this hole when first observed was approximately 0.4 cm. Additional erosion of the cathode baffle then appeared at two locations on the edge (see Figure 31). The two regions of edge erosion began diametrically opposite each other and appeared to be coincident with the axis of the cathode keeper; the cathode keeper is mounted 1.7 cm upstream from the baffle. The condition of the baffle at the conclusion of the 10,000 hr test is shown in Figure 31.

Figure 32. Photograph of optics showing flakes on screen electrode and localized erosion of accelerator electrode apertures caused by flakes. (Accelerator aperture diameter is 0.15 cm.)

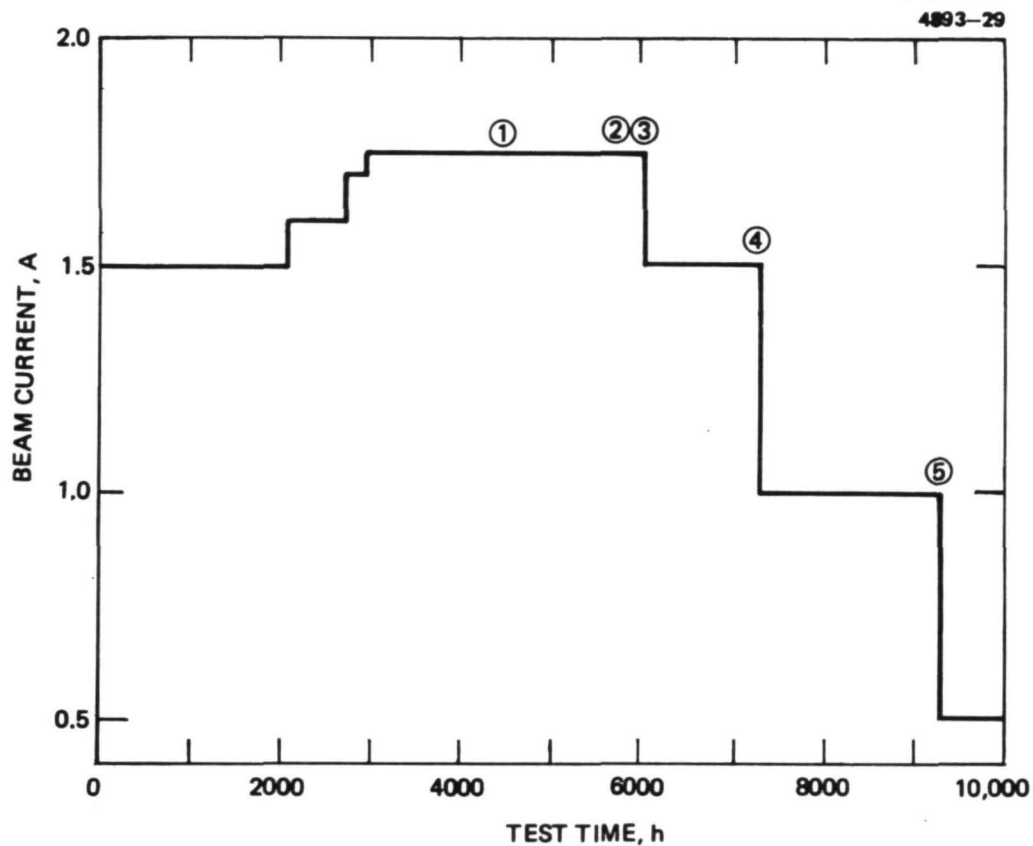
- ① FLAKES ON OPTICS AT HOUR 4530
- ② HOLE IN BAFFLE AT HOUR 5845
- ③ HIGH TRIP RATE DUE TO FLAKES
- ④ LOW DISCHARGE VOLTAGE MODE DUE TO ERODED BAFFLE
- ⑤ HIGH TRIP RATE DUE TO FLAKES AND ERODED BAFFLE

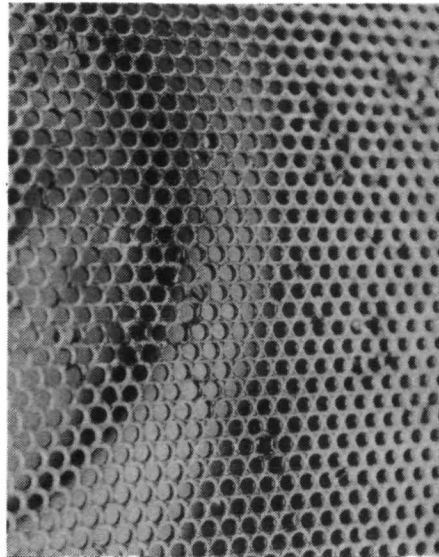
(c) DAMAGE TO ACCELERATOR
APERTURES

Figure A-3. (a) Deposition on downstream surface of outer case mask. (b) Deposition on neutralizer SN 415. (c) Damage to accelerator apertures.

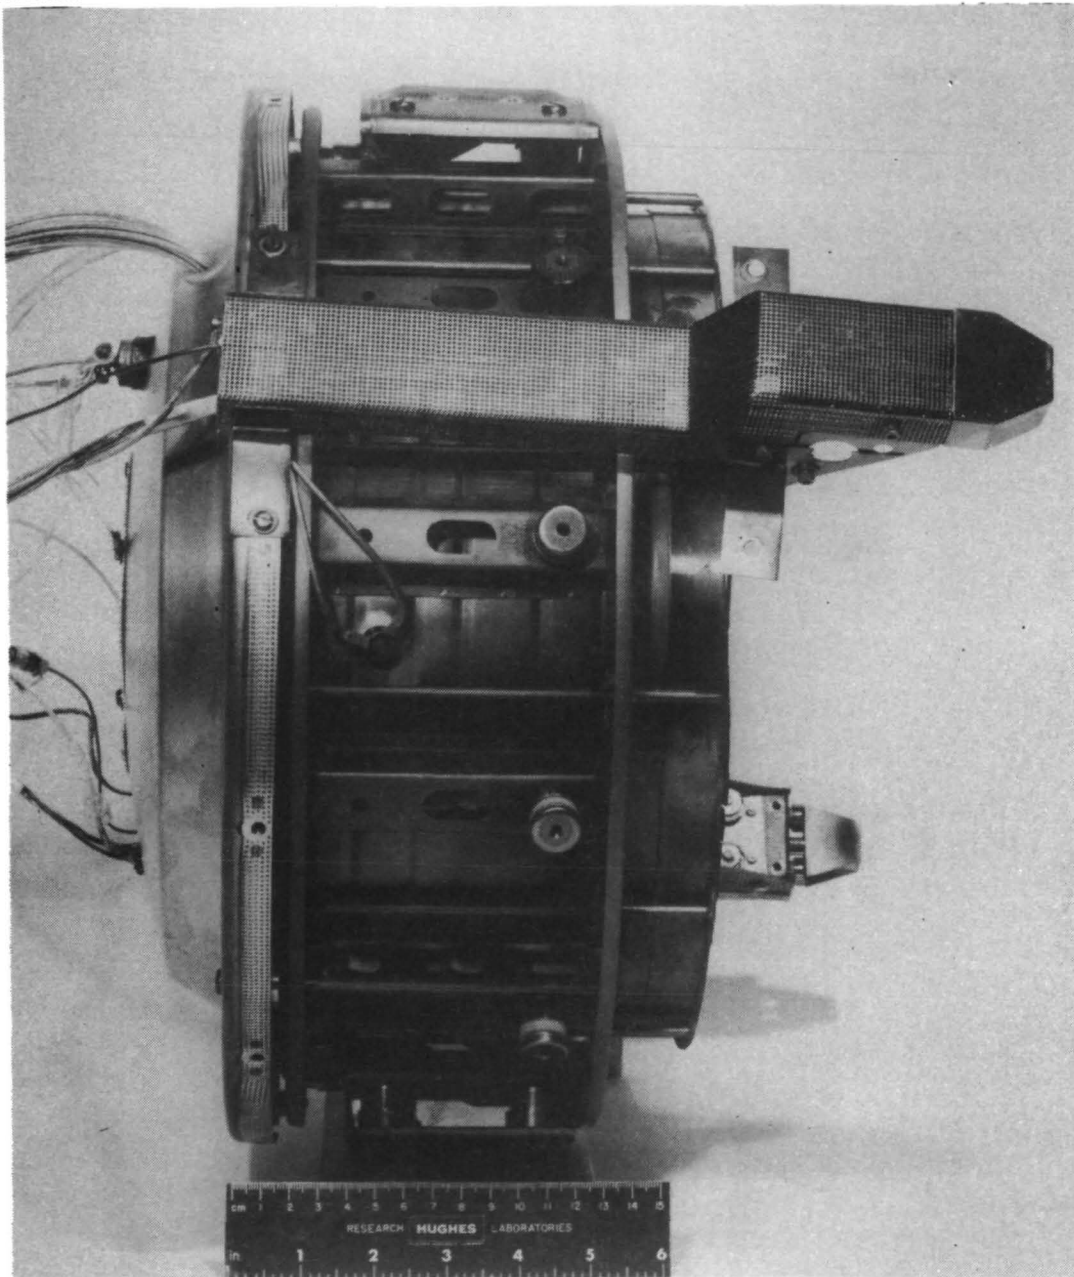
Figure A-6 is a side view of the thruster and two observations are noteworthy. First, it can be seen that two of the insulators used to support the outer case have the "shadow shields" removed, exposing the ceramic surfaces. These insulators showed no electrical leakage and the ceramic surfaces are clean and free of any discoloration. Second, on the discharge chamber shell adjacent to the anode terminal seen in the center of the photograph (arrow) a "bright" region can be seen on the metal where the insulator makes contact, surrounded by a darker region. The anode insulator leakage resistance mentioned earlier was a consequence of damage to this and one other anode support insulator. This damage will be discussed in detail in the discharge chamber section with reference made to the coloration noted here. Figure A-7 shows the opposite side of the thruster. The fracture seen in the cover on neutralizer SN 701 is considered a weakness of the prototype cover and support design and a design change has already been incorporated in thruster SN 702A.

Figure A-6. Thruster 701 — side view with ground screen removed.

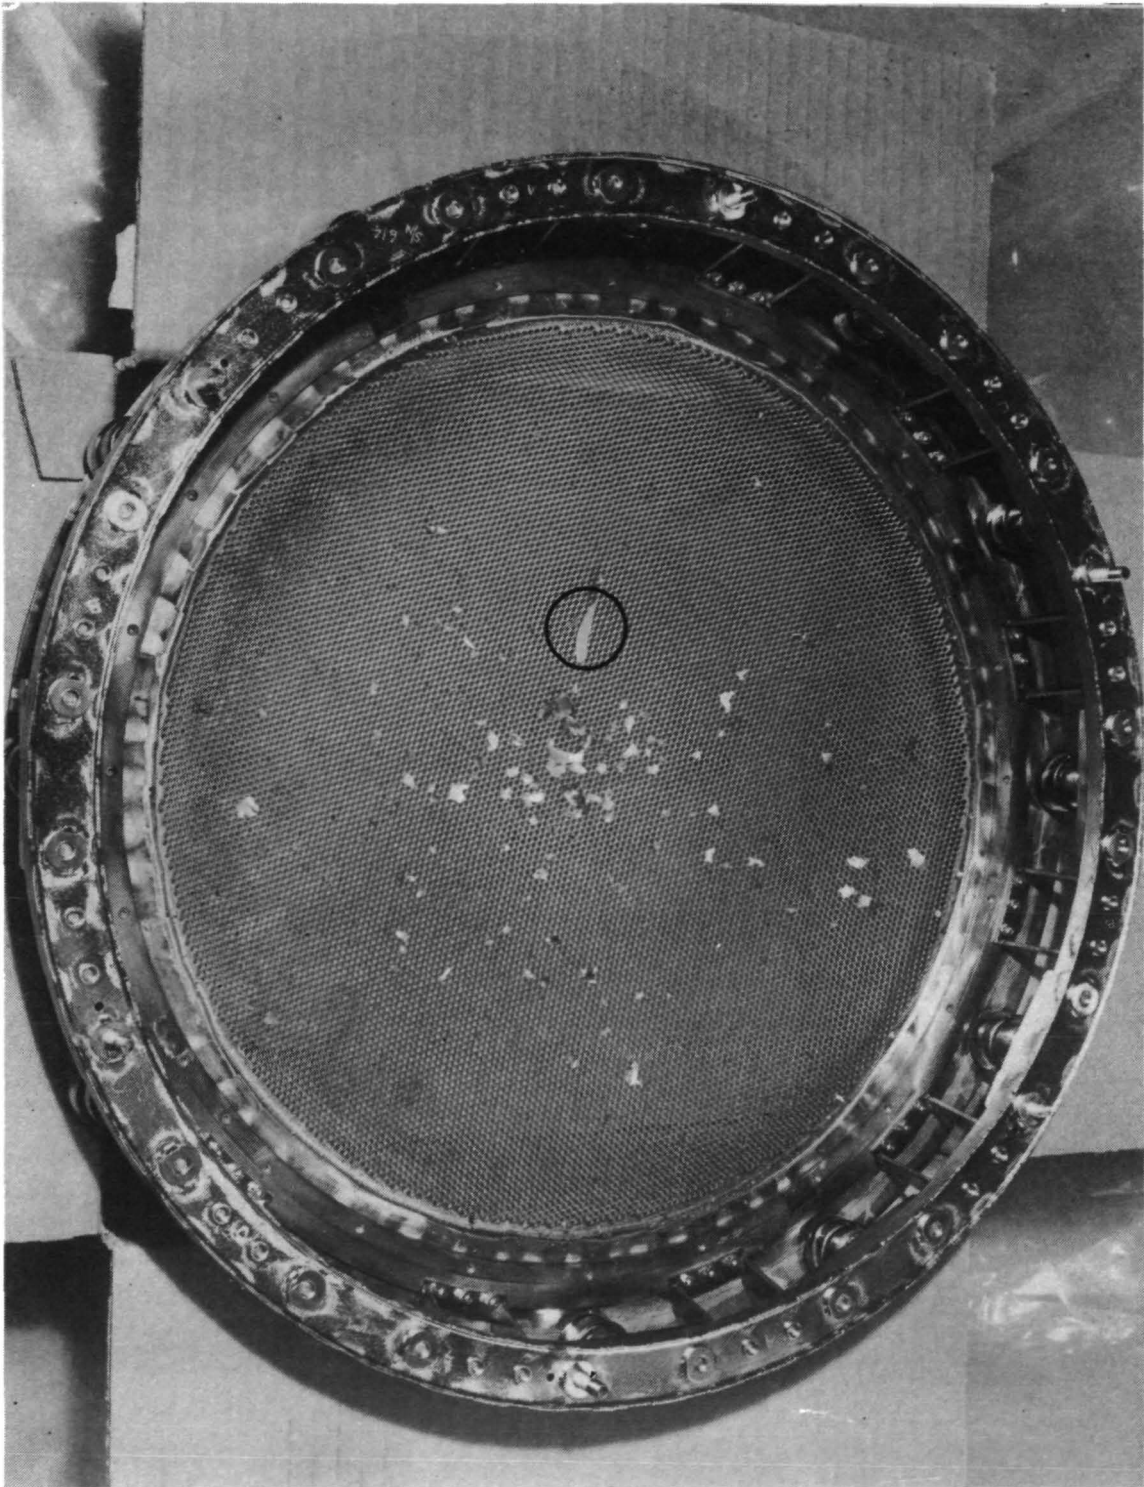
Figure A-12. Optics with flakes on upstream side of screen electrode. Encircled flake is piece of baffle.

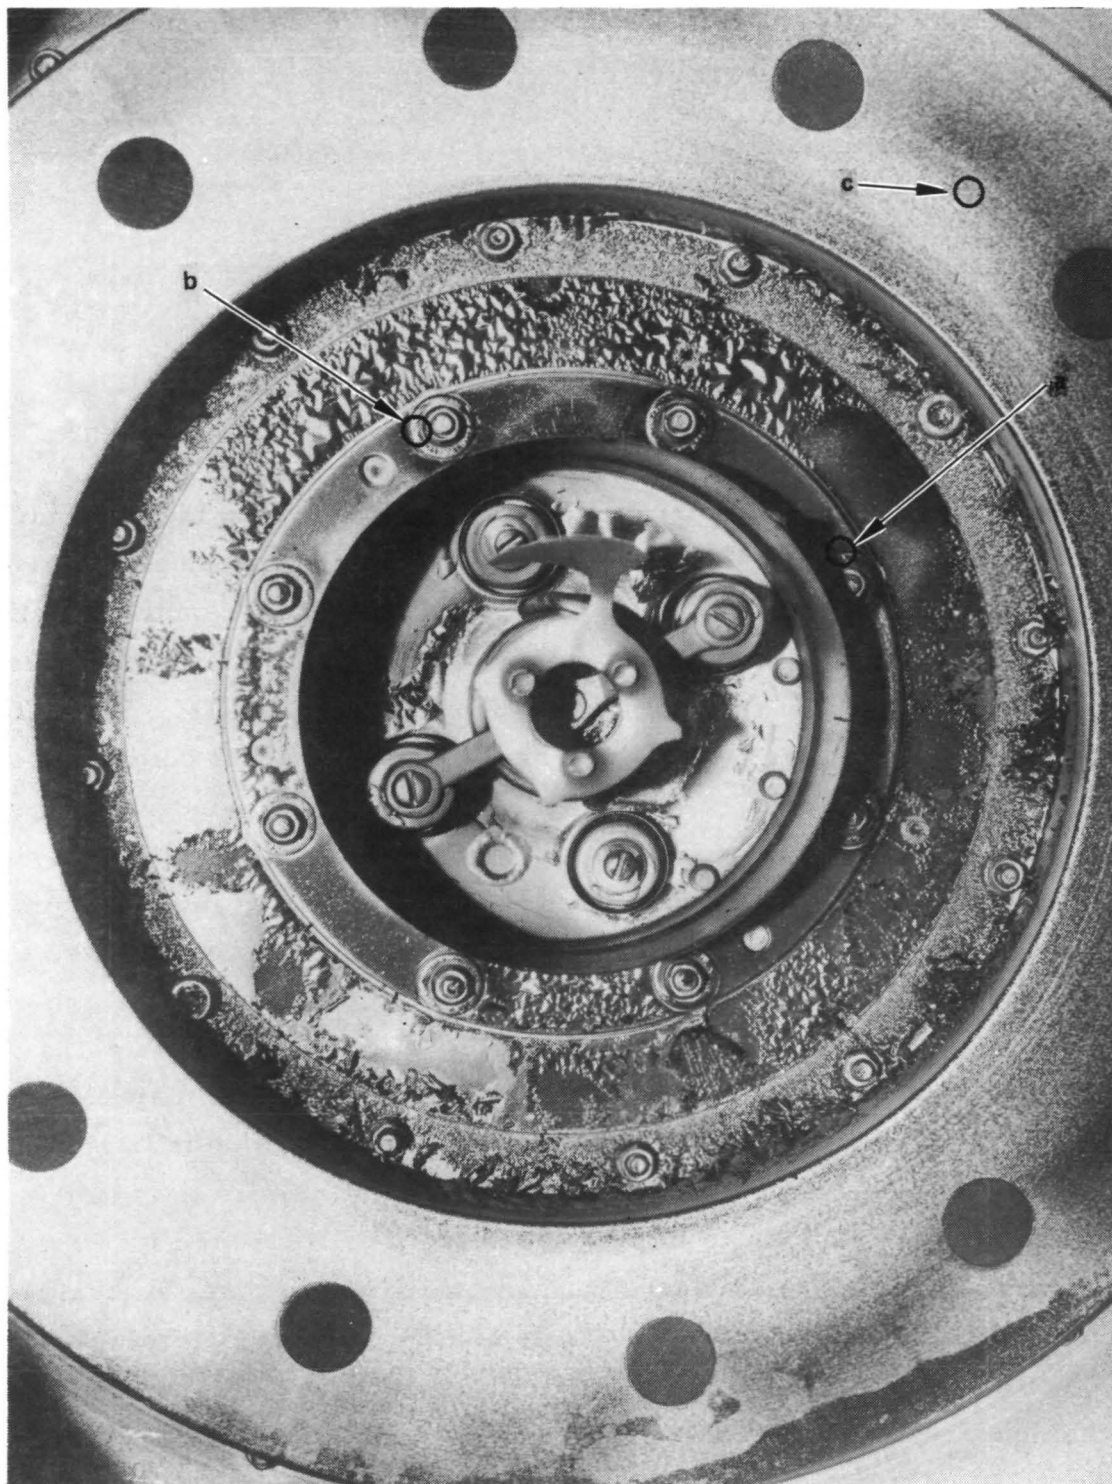
All of these elements (except the last) will be discussed in detail in this section. The cathode pole-baffle subassembly sustained the greatest wear, and its elements will be described in detail in another section. Figures A-13 and A-14 show the extent of this wear. (For comparison, a photograph of a new subassembly is shown as Fig. A-15.) The baffle is eroded almost completely away, exposing the internal components of the subassembly to ion bombardment. Similarly, the pole piece is seen to be thinned to a "knife-edge" at the downstream edge. The material removed from these components is re-deposited on the internal surfaces of the discharge chamber, and, as the coating builds in thickness, the deposited material spalls and forms "flakes." These deposits are evident in Figs. A-13, A-14, A-16, and A-17 primarily on the upstream discharge chamber boundary or backplate and the anode. Samples of these deposits were taken at the locations marked on the photographs in Figs. A-13 and A-16 and analyzed to provide the results listed in Table A-4. Except for the deposit taken from the outboard location on the backplate (L), the samples were comprised predominantly of iron. The sources of this iron are the baffle and the cathode pole which are fabricated from cold rolled electrolytic steel. The other constituents and impurities anticipated to be present in steel are also in evidence.

Figure A-13. Cathode pole-baffle region.

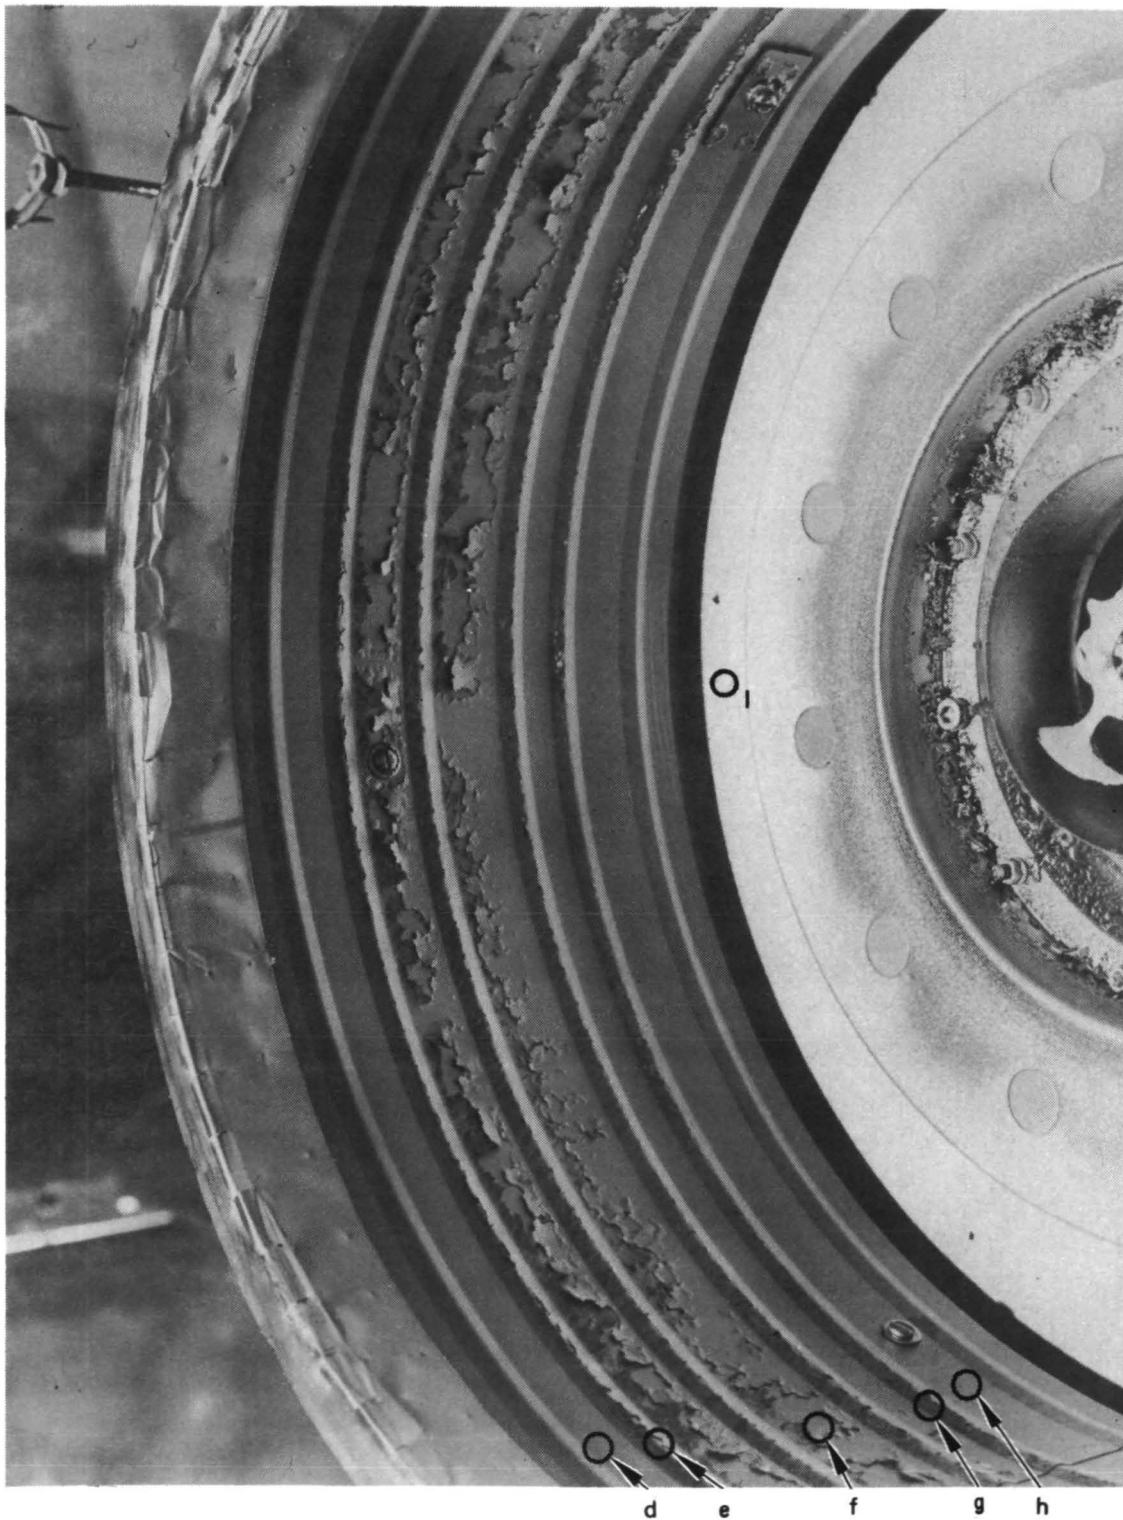
Figure A-16. Sputter deposition on anode.

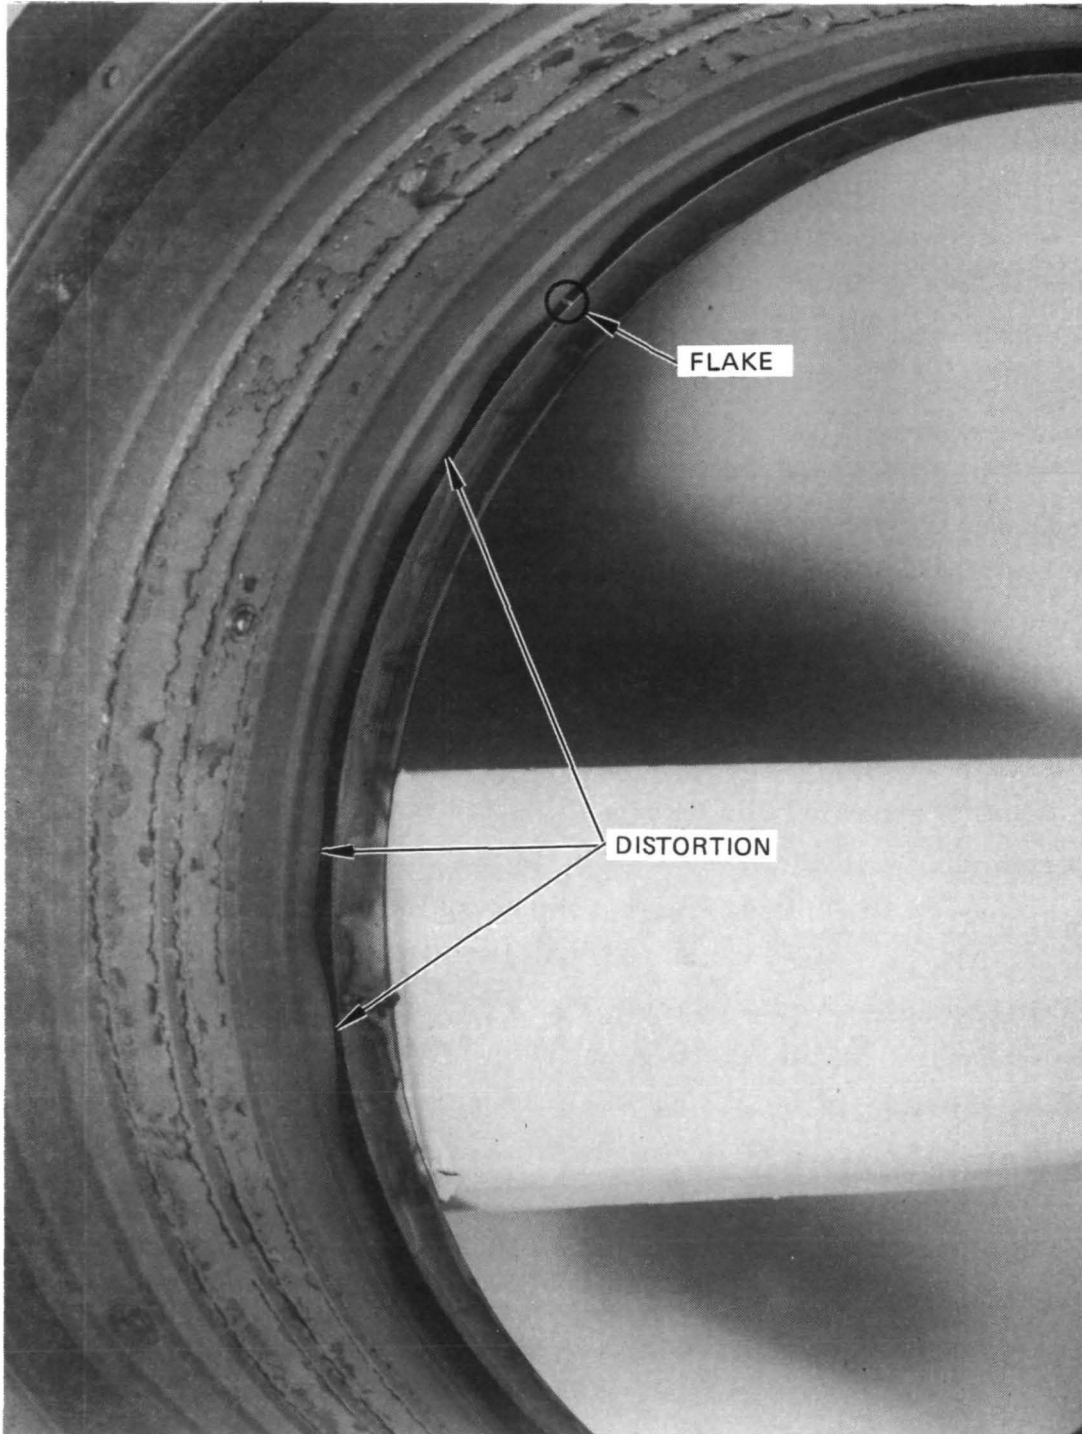
Figure A-20. Part of anode showing distortion and flake.

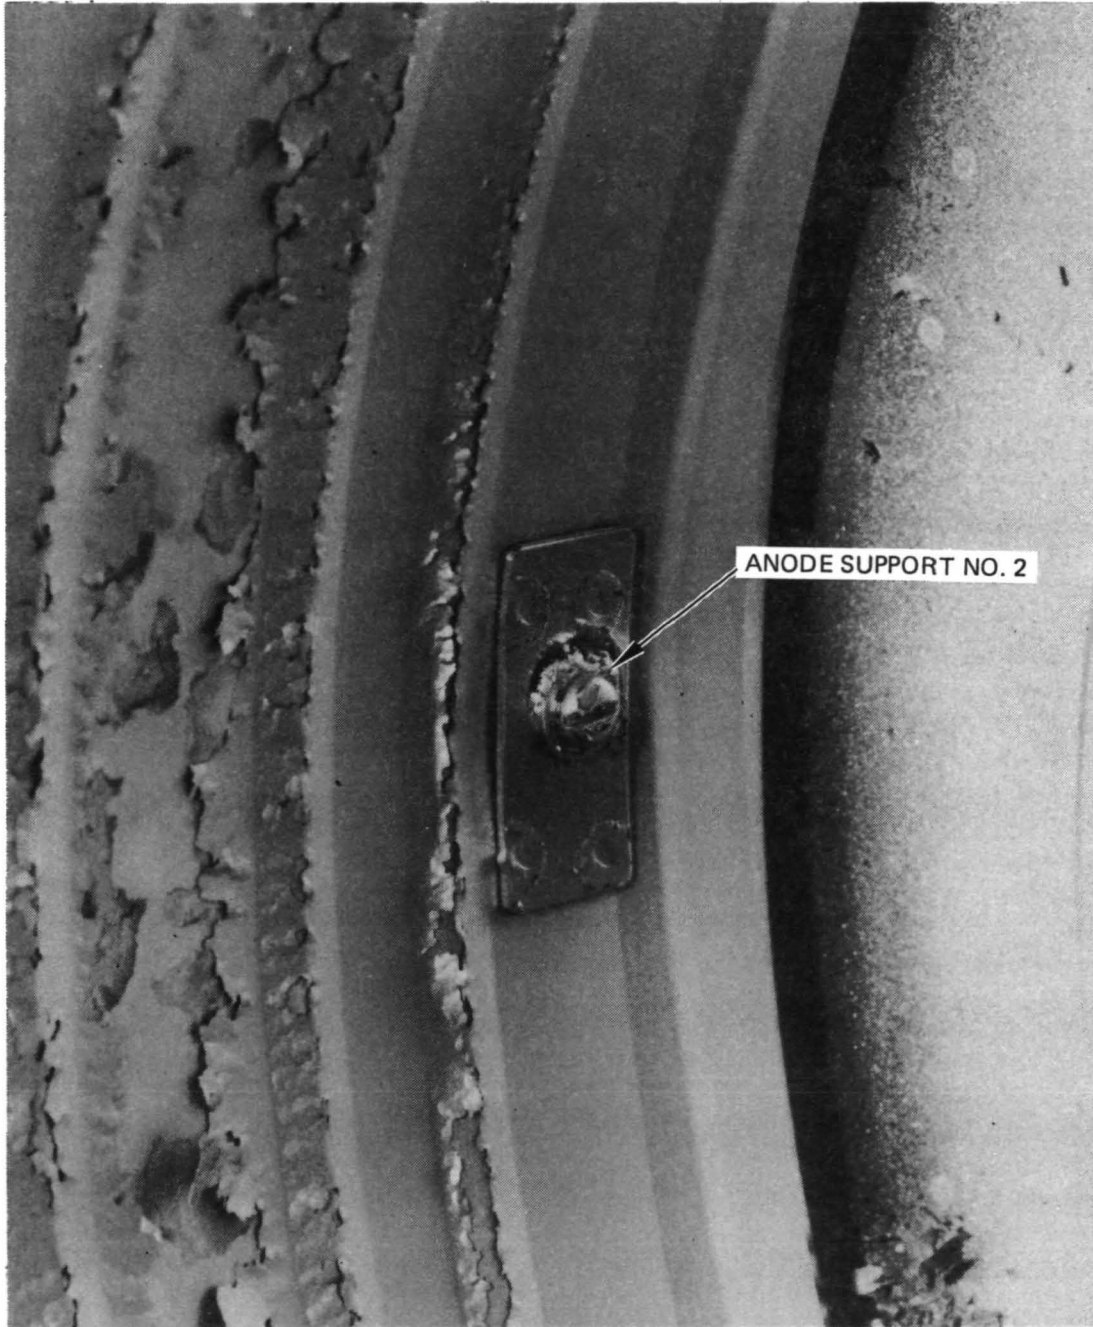
An interaction between the anode and the anode fasteners can be seen on two of the six fasteners which hold the anode in place. The anode supports numbered 1, 3, and 5 were nearer the downstream end of the discharge chamber, while numbers 2, 4, and 6 were located nearer the upstream end. Enlarged photographs of these two fasteners are shown in Figs. A-21 and A-22 (which will be referred to as anode support numbers 6 and 2, respectively). The stainless steel screw of anode

Figure A-22. Part of anode showing damaged anode support No. 2.

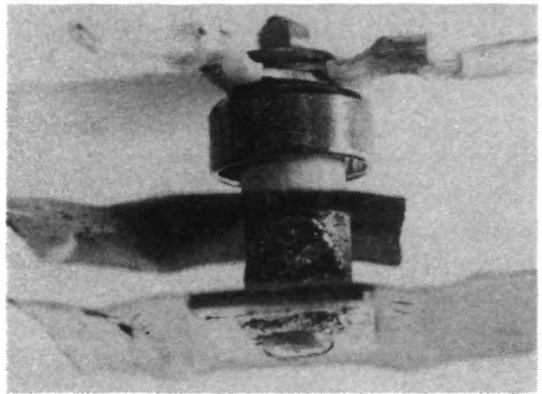
Figure A-25. Damaged anode support No. 2.

The damage to the anode support insulators is concluded to be a melting or fusion of the Al_2O_3 insulator, the Ti anode, and the stainless steel machine screw. On the basis of the observable evidence, the only logical explanation of this melting is that local high temperature produces some alloying of the Ti and Al to form a moderately low temperature eutectic ($\sim 600^\circ$ to 800°C). On the basis of the "arc tracks" visible on the thruster shell, formation of a vacuum arc breakdown in the vicinity of the insulator seems to be the best explanation which can be offered for generation of these temperatures. Except for the coating seen on the insulator surface, there does not appear to be any deterioration of the bulk material. Because of the relatively low voltage applied to the anode, formation of an arc by the discharge supply might be considered unlikely, unless the applied voltage appears across a very small gap. This condition could be established if a conductive coating covered the entire anode support insulator except for a small gap between the anode and the insulator as shown in Fig. A-40. The coating and gap are shown on an exaggerated scale to illustrate the conjecture being developed here. The insulator surface would most probably charge to thruster shell potential because the thruster shell is clamped firmly between two mating

The fourth (and final) change in the discharge chamber was also a consequence of the 10,000 hr endurance test. During the post-test disassembly of thruster 701, it was discovered that two of the six anode insulators had suffered damage. After an extensive investigation, including scanning electron microscope photography and K_{α} X-ray analysis, it was concluded that the damage to the anode insulators was a direct result of the deposition of sputtered material (see Appendix A). Therefore, in the 900-series thrusters, shadow shields have been placed over the anode end of the anode insulators. Insulator material was also changed from Al-300 to Lucalox.

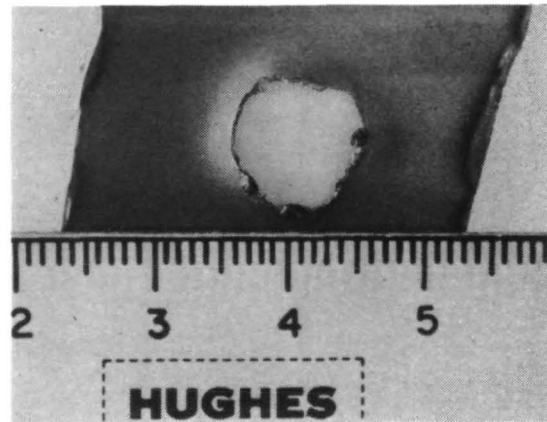
Figure A-26. Damaged anode support No. 6.

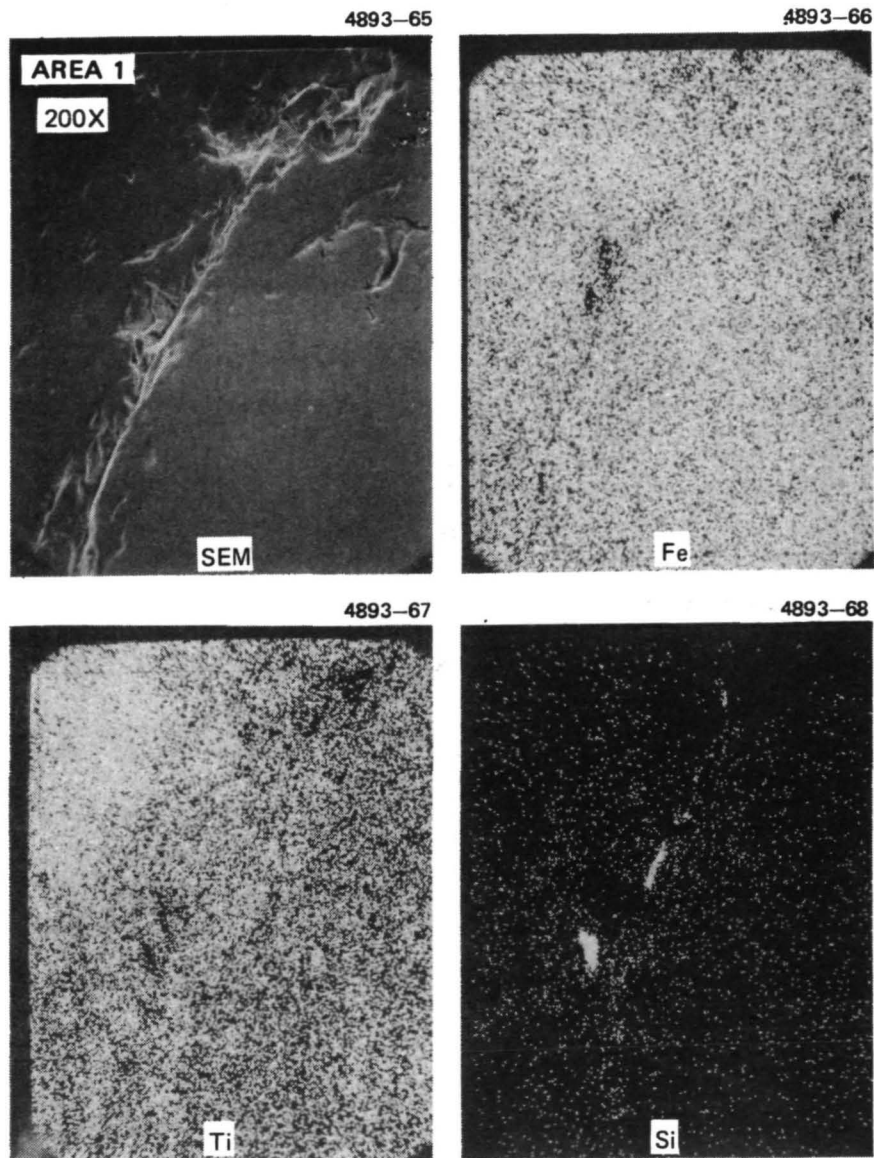
Figure A-34. Scanning electron microscope photo and K_{α} X-ray analysis of area 1 of anode support.

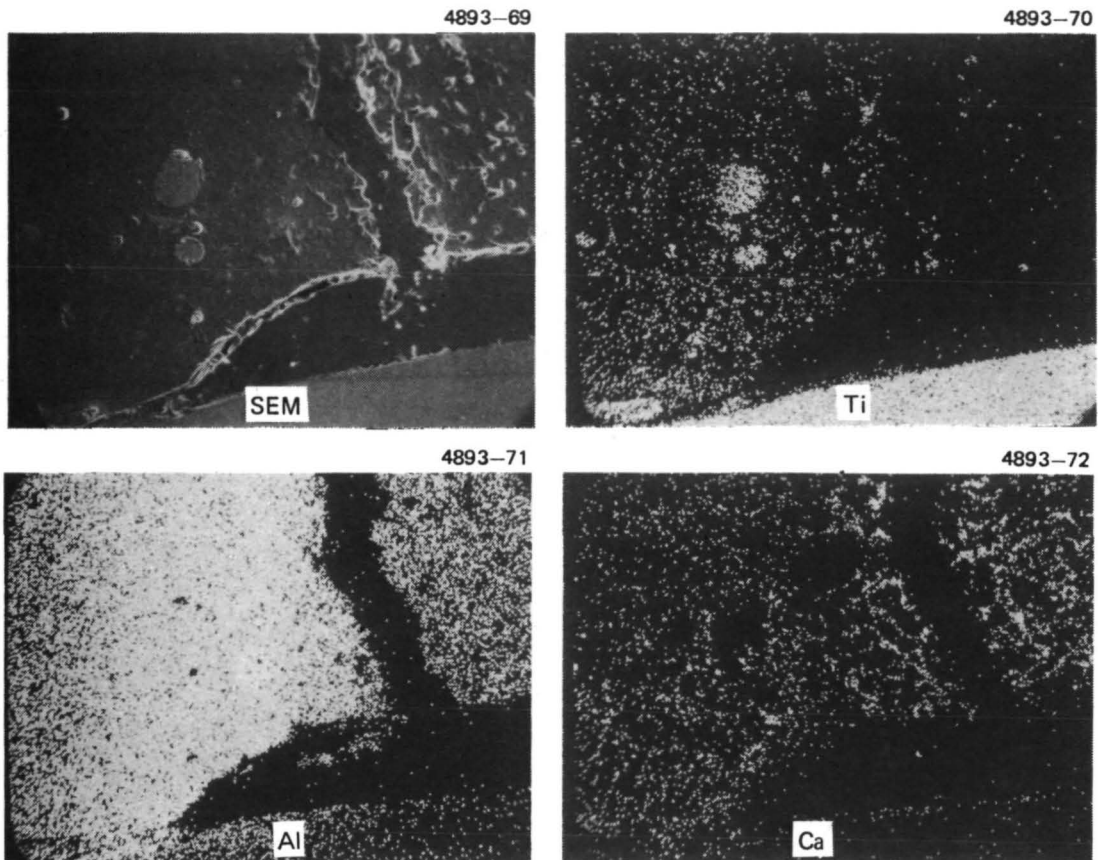
Figure A-35. Scanning electron microscope photo and K α X-ray analysis of area 2 of damaged anode support.

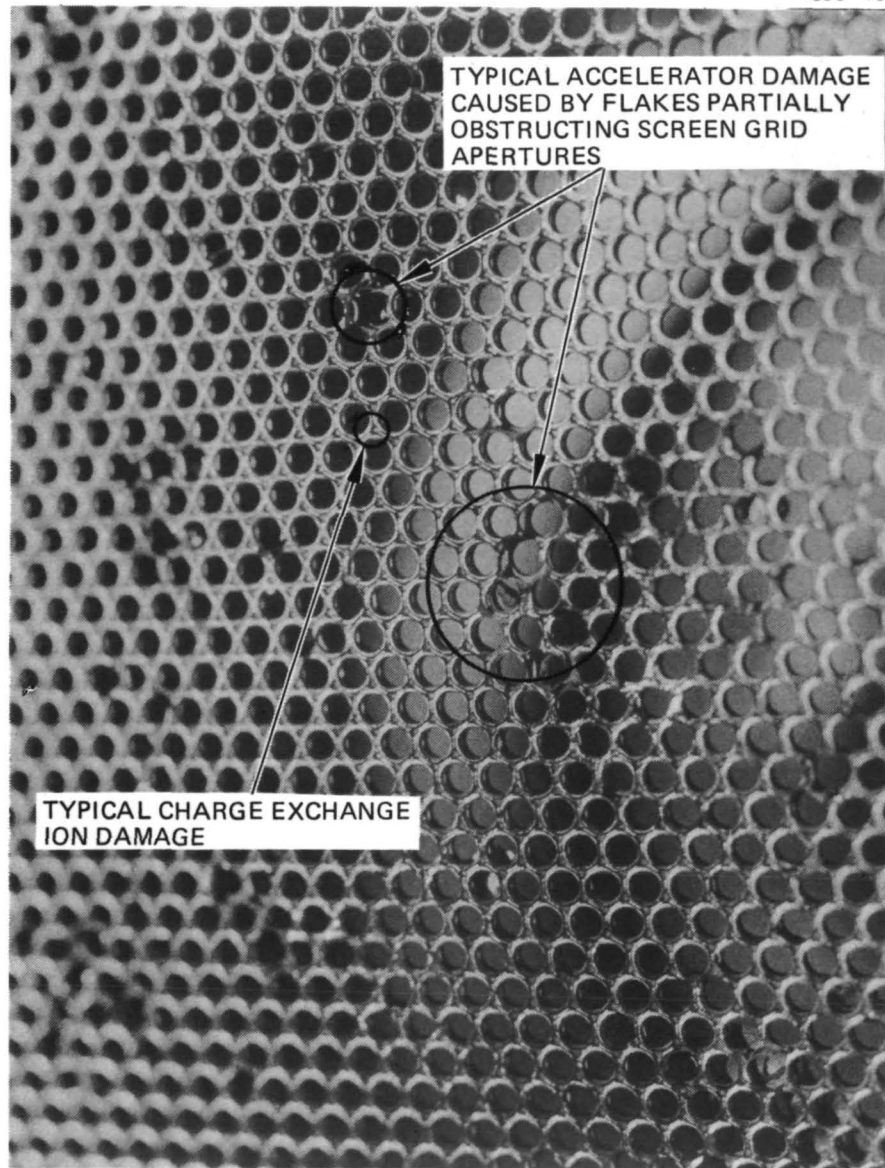
electrode was caused by direct interception of high-energy ions which were deflected or defocused by flakes of material partially covering screen grid apertures (as seen earlier in Figs. A-1 and A-12). Several examples of damage of this type are pointed out in Fig. A-57. The typical pattern of "pits" and grooves caused by charge exchange ions is also seen. Photographs comparing the downstream side of the accelerator electrode before and after testing are shown in Figs. A-58 through A-67. By careful examination of these photographs (or the actual electrodes under a microscope), it is seen that the ion machining damage is randomly distributed and irregular in form. The erosion caused by charge exchange ions, on the other hand, is quite uniformly distributed and exhibits a well defined pattern. This pattern is oriented to the hexagonal aperture array but does not show any region of accelerated wear that would indicate the neutralizer location. Thus, the major difficulty observed in the SERT II tests is not at all in evidence here.

Figure A-57. Accelerator electrode, downstream view.

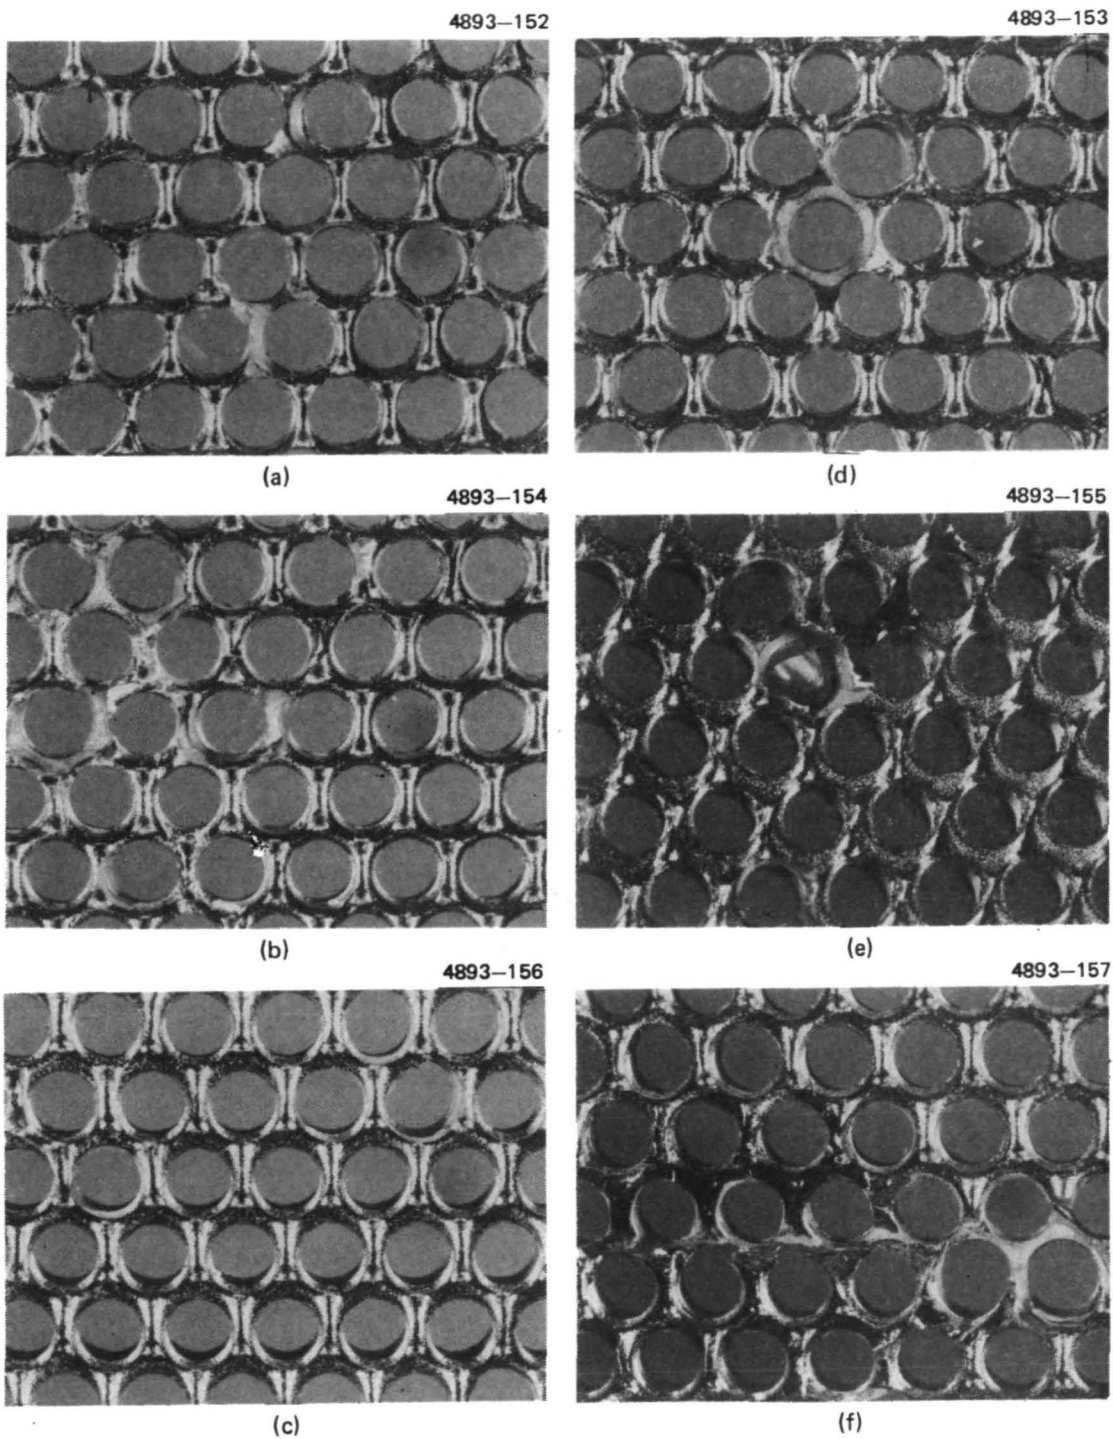
Some selected areas of damage are shown magnified in Fig. A-68. Note that in the views shown as (b) and (f), some webs of material between the apertures have been cut through completely by beam ions. View (e) shows a flake lodged in the electrodes and the resultant damage. Views (a), (b), and (c) illustrate the change in orientation of the charge exchange erosion patterns that can be seen as a function of thruster radius. The orientation of these photographs places the center of the electrode at the top of the page and view (a) is nearest the center, while view (c) is nearest the edge. It is apparent that the erosion is deepest near the electrode center, view (a), and that the erosion pattern is centered on and symmetric with the aperture pattern. Nearer the edge, as in Fig. A-68(c), the erosion is less and the pattern is shifted towards the grid center. This offset in the erosion pattern occurs because the beamlets formed at the edge apertures are by grid design deflected radially inward to counteract the divergent effect introduced by grid curvature and therefore the charge exchange ions are also focused towards the grid center.

Figure A-68. Selected areas of downstream surface of accel electrode.

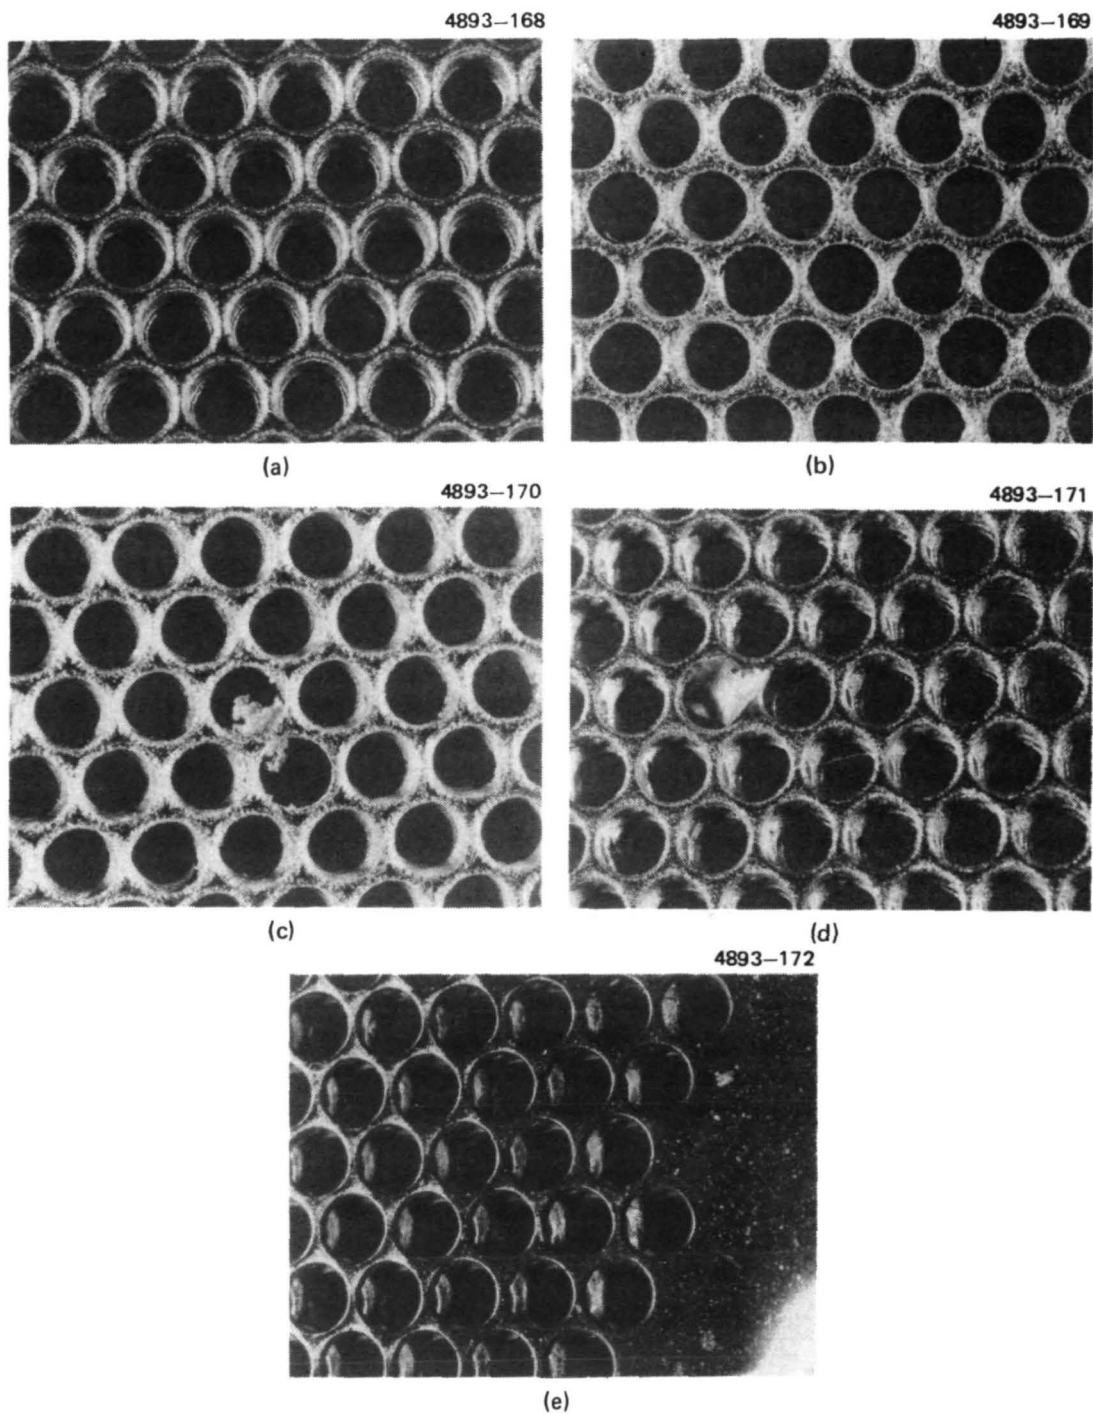
Figure A-87. Selected areas of upstream side of screen electrode.

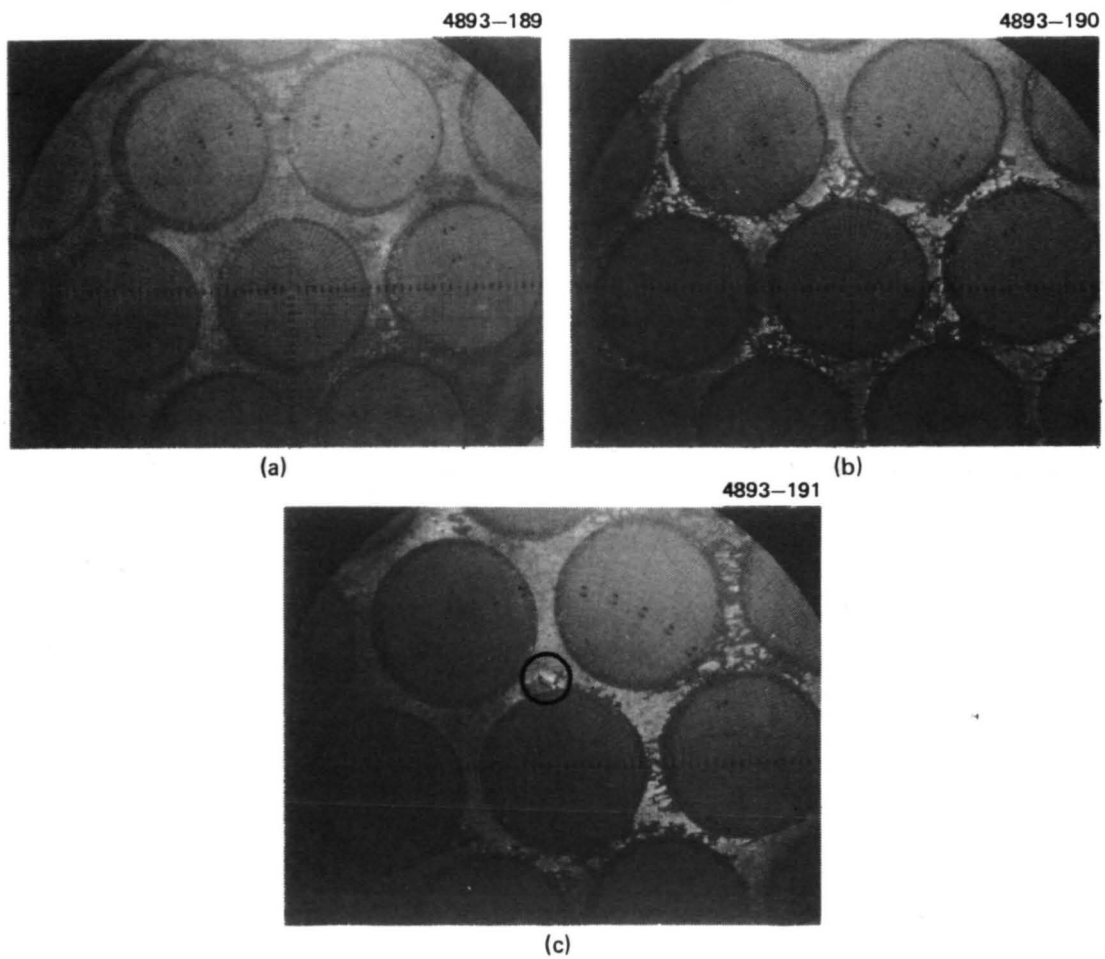
Figure A-96. Magnified view of selected areas of downstream surface of screen electrode.

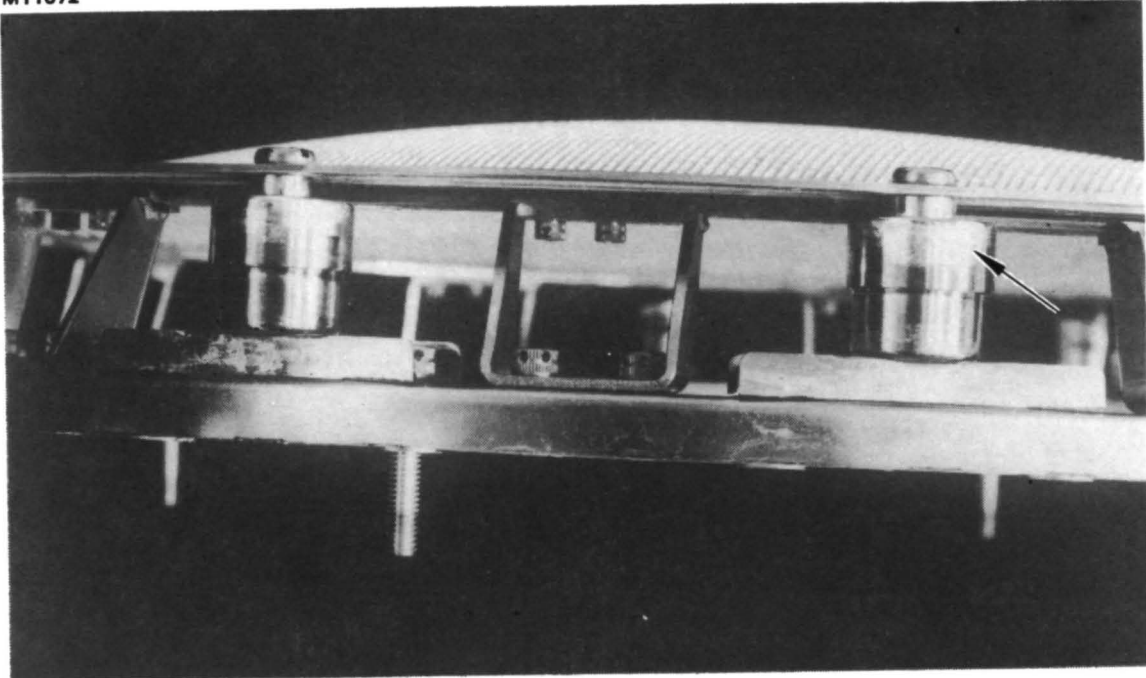
Figure A-97. Optics showing markings on insulator shields.
